UNITED STATES ENVIRONMENTAL PROTECTION AGENCY Region 1 New England

Inspection Report

GenOn Kendall, LLC subsidiary of NRG Energy Cambridge, MA

Date of inspection: September 4, 2013

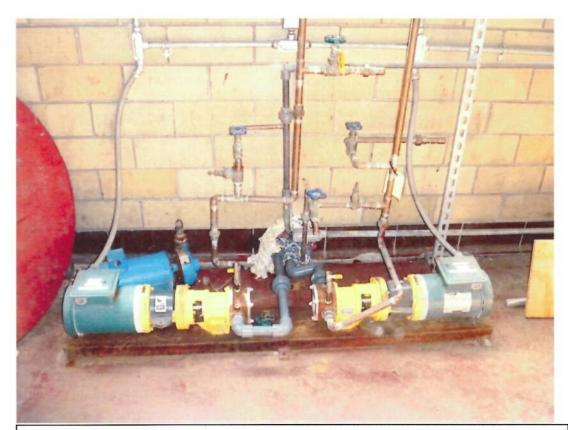
There are 2 pumps that transfer cooling water from the effluent 2 pipes for sampling. There is a spigot on each line that is opened and run into a gallon bucket before grab sampling for pH and total residual chlorine.

- 1 photograph was taken of the sampling location for the 2 outfall discharge pipes to the Charles River.
- Raw canal water TRC ranges from 0.02 to 0.49 mg/l by DPD method. Evaluate in the future whether the measurements are real. Since there is a city culvert discharge upstream of the facility intake, there could be TRC in the canal water.

GenOn Kendall 9/4/13 @ 1202 Cooling water sampling location
